2016 Annual Site Inspection and Monitoring Report for Uranium Mill Tailings Radiation Control Act Title II Disposal Sites

November 2016

**U.S. Department of Energy
Office of Legacy Management**

**2016 Annual Site Inspection and Monitoring Report
for
Uranium Mill Tailings Radiation Control Act
Title II Disposal Sites**

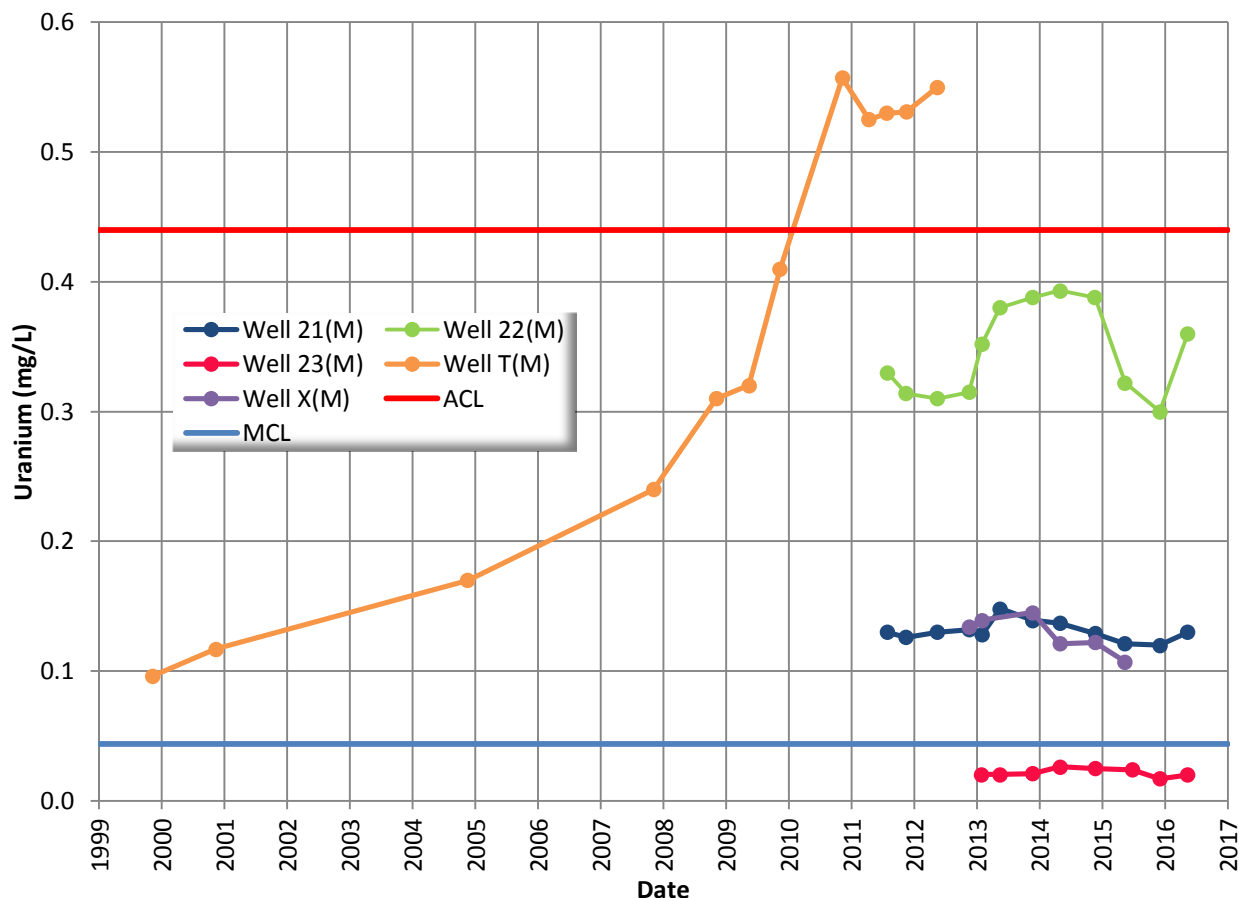
Figure 1-3. Uranium Concentrations in Alluvial Aquifer POC Well T(M) and Downgradient Wells at the Bluewater, New Mexico, Disposal Site

Alluvium well 21(M), installed in 2011, is adjacent to the southern site boundary, where the estimated deepest part of the ancestral Rio San Jose channel coursed before being buried by basalt lava flows. Alluvium well 22(M), also installed in 2011, is approximately halfway between POC well T(M) and well 21(M). The uranium concentrations in these two newer wells are less than the ACL (Table 1-4). However, the uranium concentrations in both wells, shown on

Figure 1-3, continue to exceed the UMTRCA MCL of 0.044 mg/L (40 CFR 192, Table 1) and the State of New Mexico drinking water standard of 0.03 mg/L. The elevated uranium concentrations in well 21(M) and POE well X(M) indicate that alluvial groundwater with uranium concentrations exceeding the drinking water standard is leaving the site.

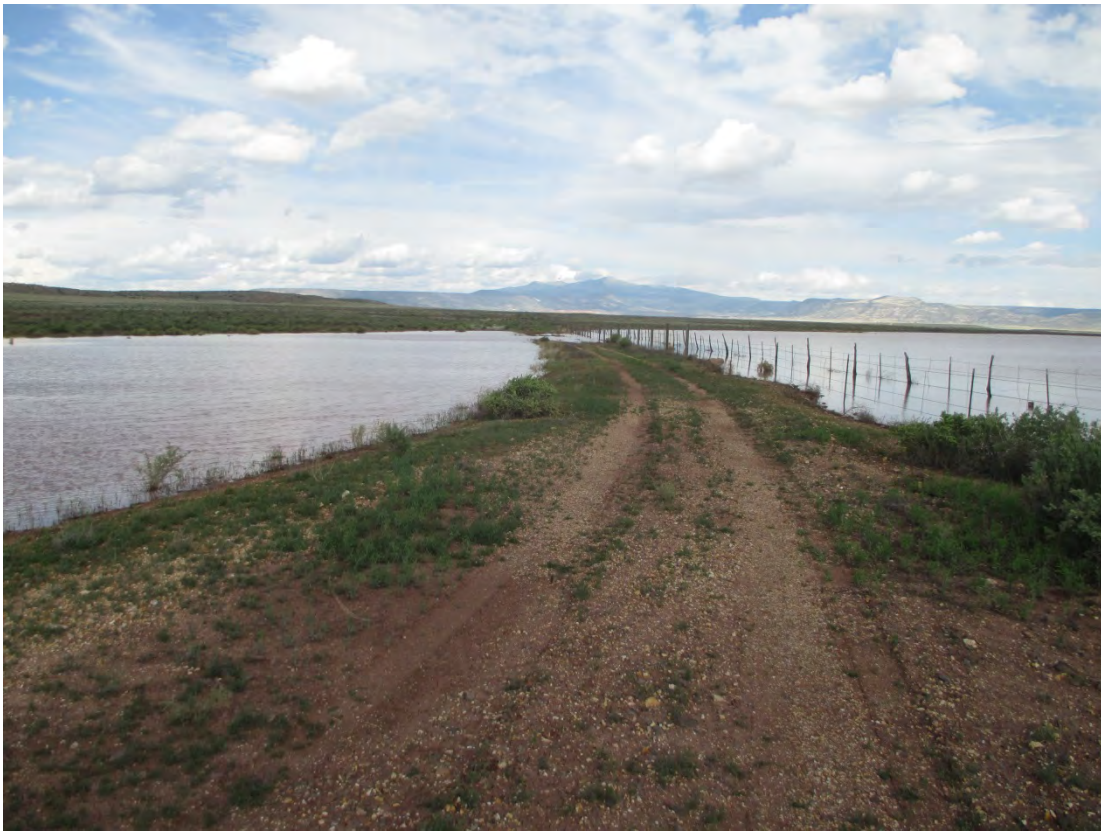
Interior tertiary roads used to access DOE assets consist of a dirt track covered at places with crushed basalt. The roads are susceptible to erosion and are repaired when they become impassable. All roads were passable except for a location that was covered by a large ephemeral pond (PL-1).

PL-1. Large Ephemeral Pond in East Portion of Site

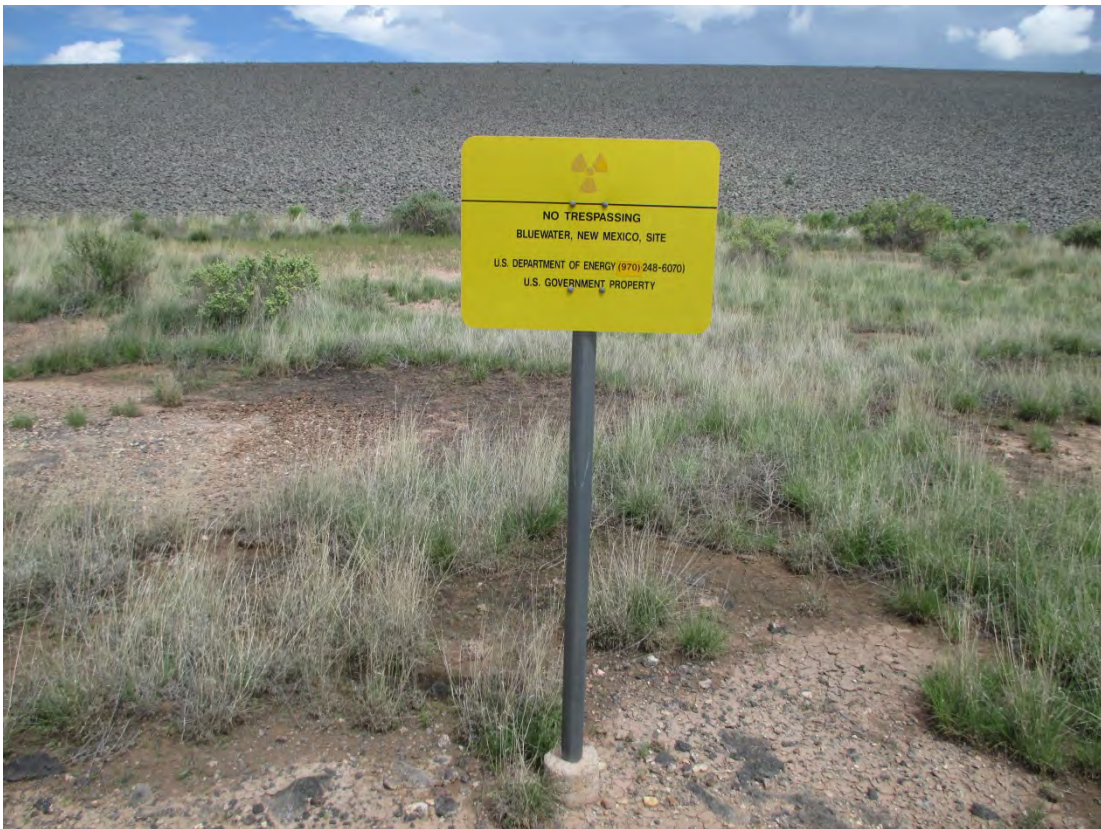
Fifty-five perimeter signs (warning and no-trespassing signs) are mounted on steel posts along the site boundary and around the main and carbonate tailings disposal cells (PL-2). Perimeter signs P3 and P10 have gunshot damage but are still legible. No maintenance needs were identified.

PL-2. Perimeter Sign P51

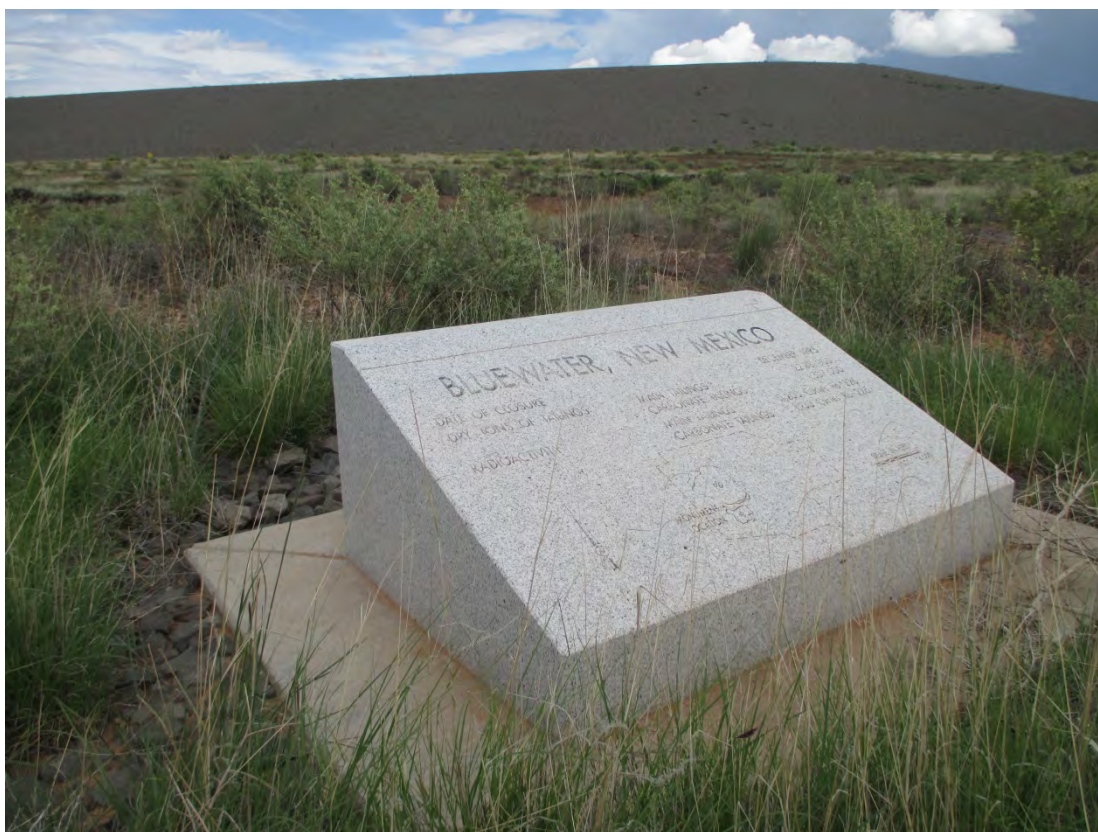
A granite site marker is between the southwest corner of the main tailings disposal cell and the northwest corner of the carbonate tailings disposal cell (PL-3). No maintenance needs were identified.

PL-3. Site Marker and South End of Main Tailings Disposal Cell

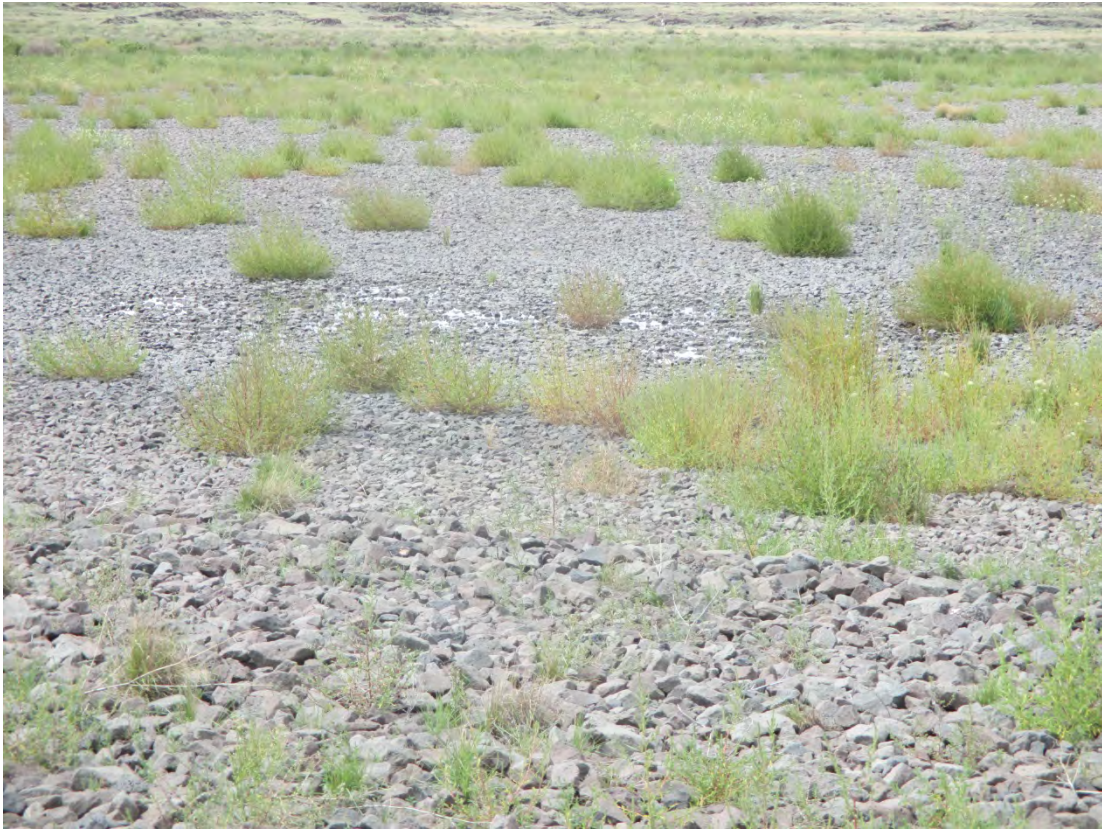
PL-13. Ponded Water on Northwest Extension of Carbonate Tailings Disposal Cell

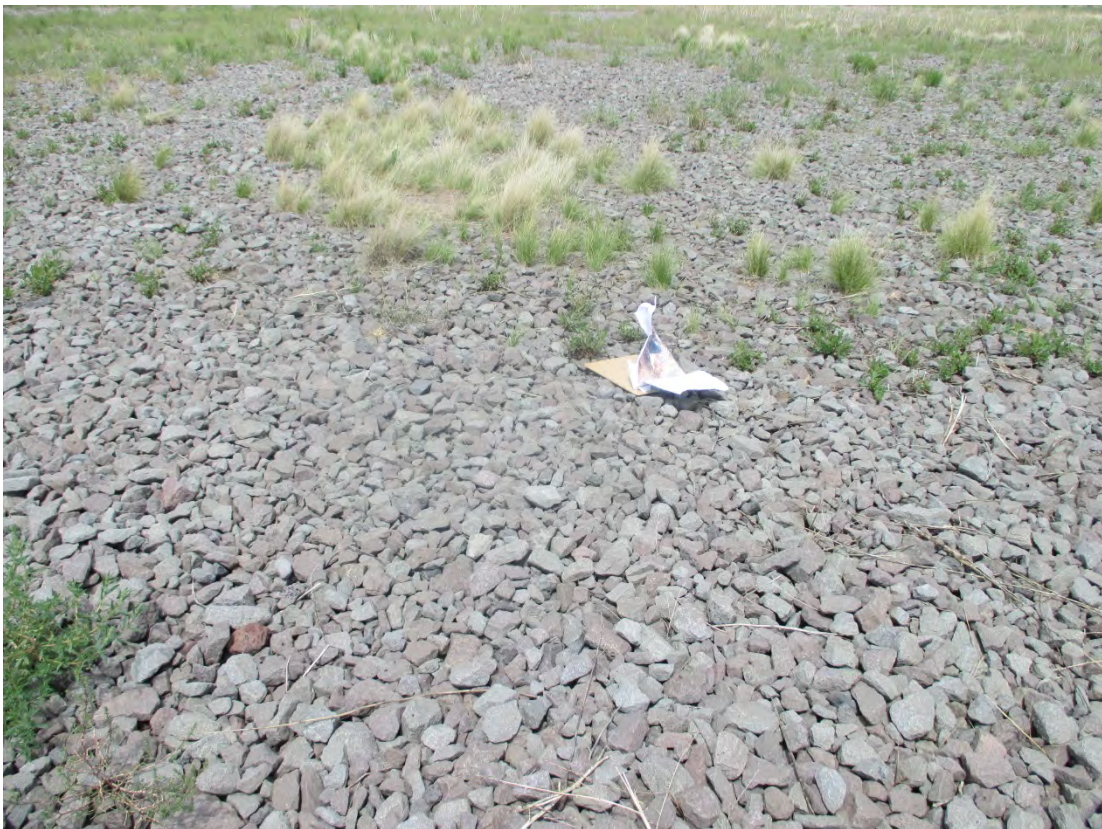
Two test pits were dug and sampled on the top slope of the carbonate tailings disposal cell as part of the NRC/DOE radon study. The test pits were reclaimed after completion of field investigations, and the locations were observed and photographed during the annual inspection. Reclamation appeared to be successful at both test pit locations; no settlement or erosion was visible (PL-14).

PL-14. Reclaimed Test Pit 7

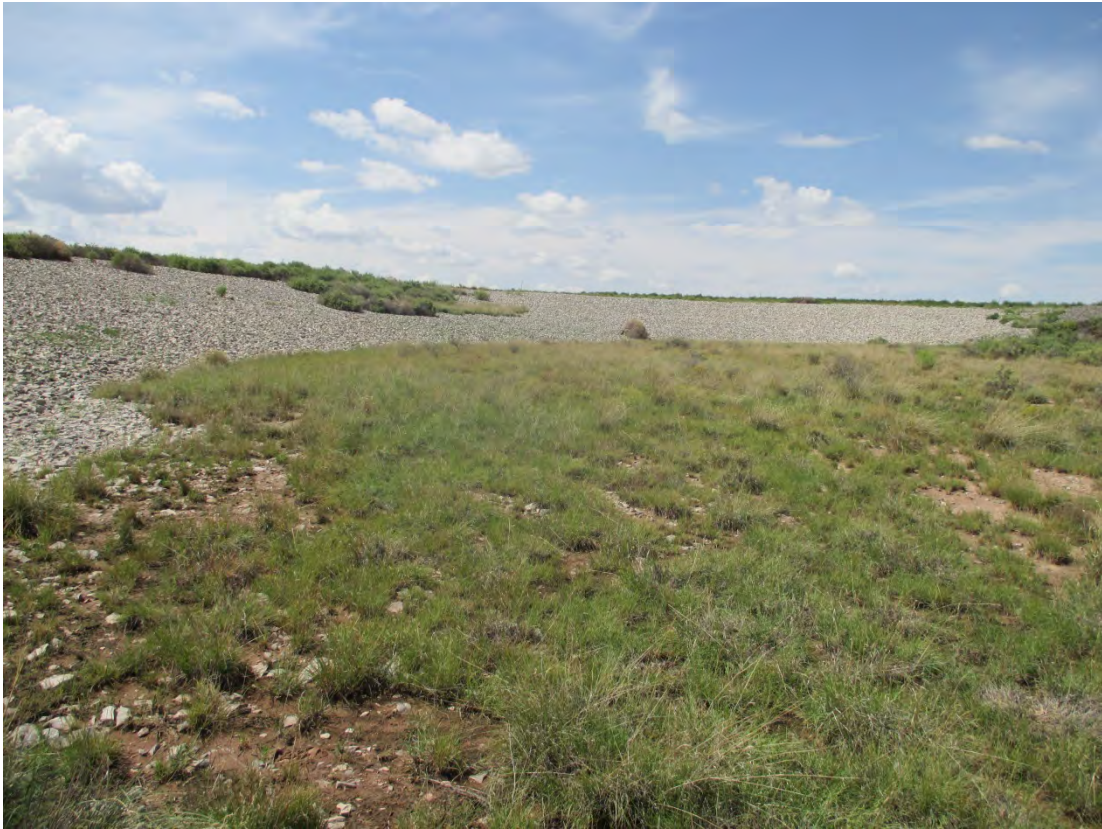
The 2-acre asbestos disposal area is a bowl-like feature just south of the carbonate tailings disposal cell (PL-15). The north, west, and south side slopes of this feature are covered by limestone riprap; the bottom of the bowl (the asbestos cell cover) is grass-covered. Several small depressions are present around the perimeter of the disposal area where relocated clean soil (placed for slope grading) has filtered down through basalt joints and fractures. These depressions do not affect the integrity of the disposal area. No maintenance needs were identified.

PL-15. Asbestos Disposal Area

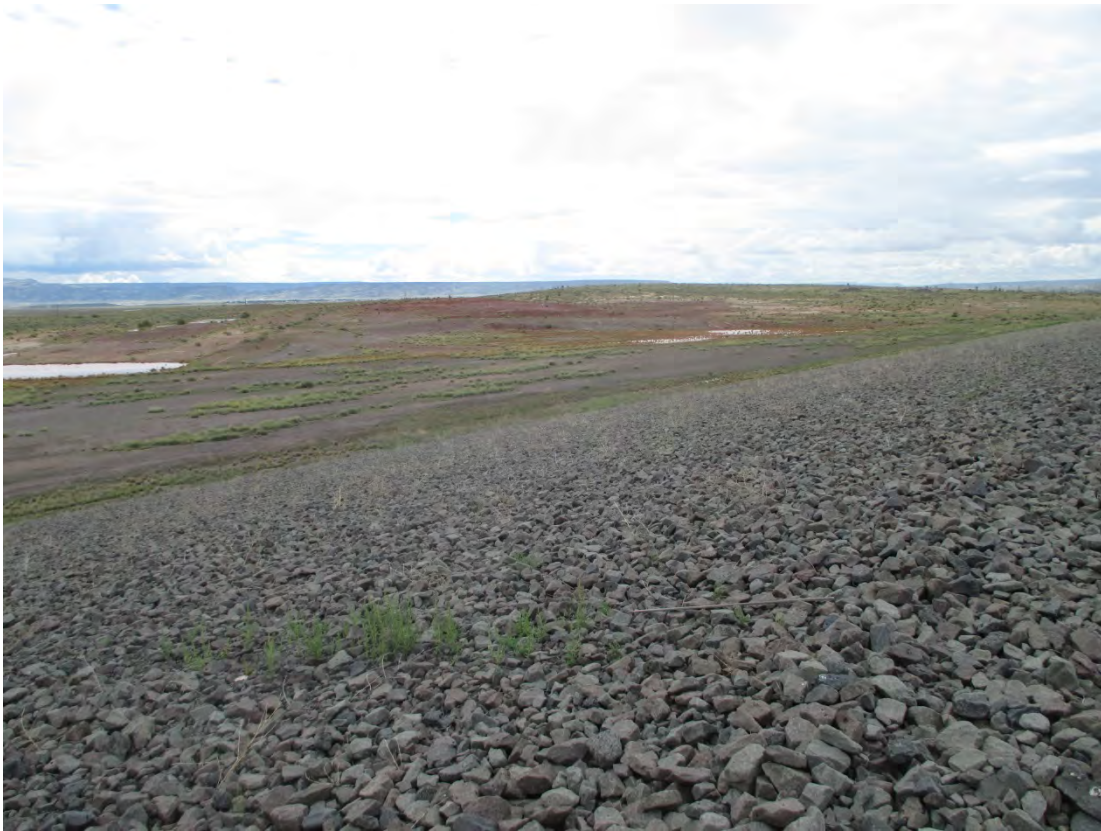
PL-17. Ephemeral Ponds Near East Side of Main Tailings Disposal Cell

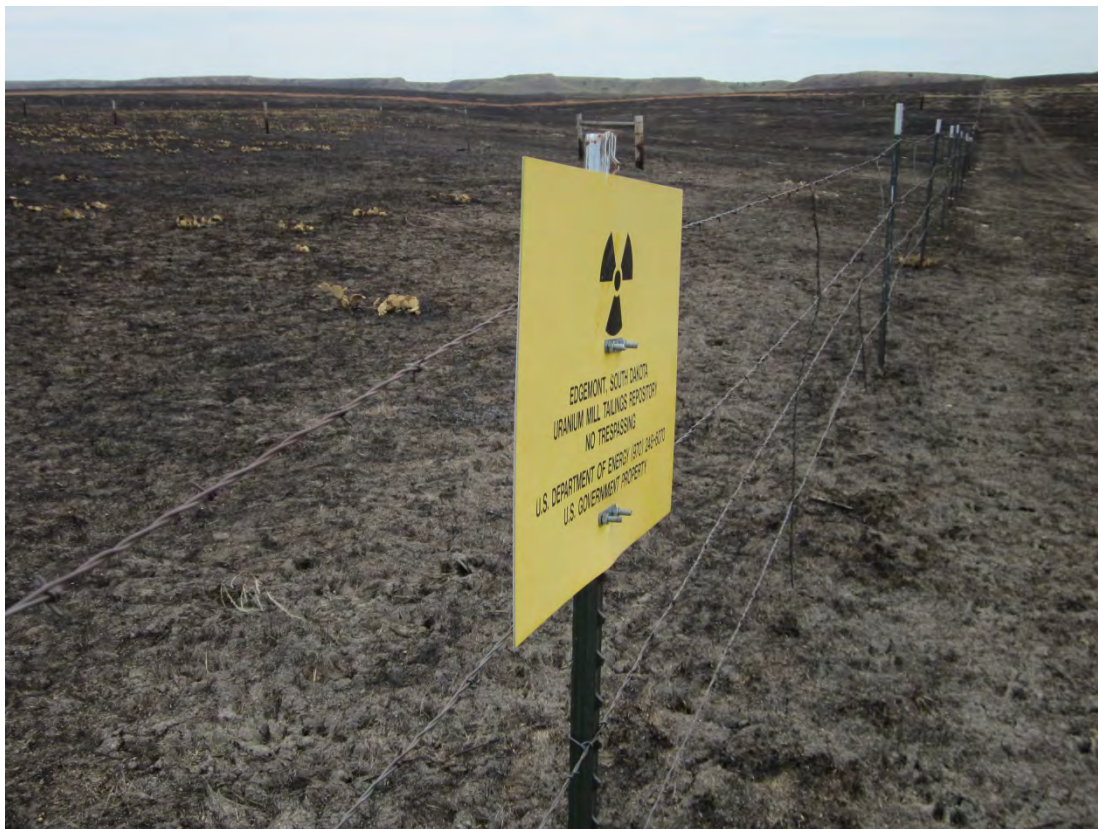
PL-1. Wire Gate and Perimeter Sign P1 Near Northwest Corner of Site, July 22, 2016

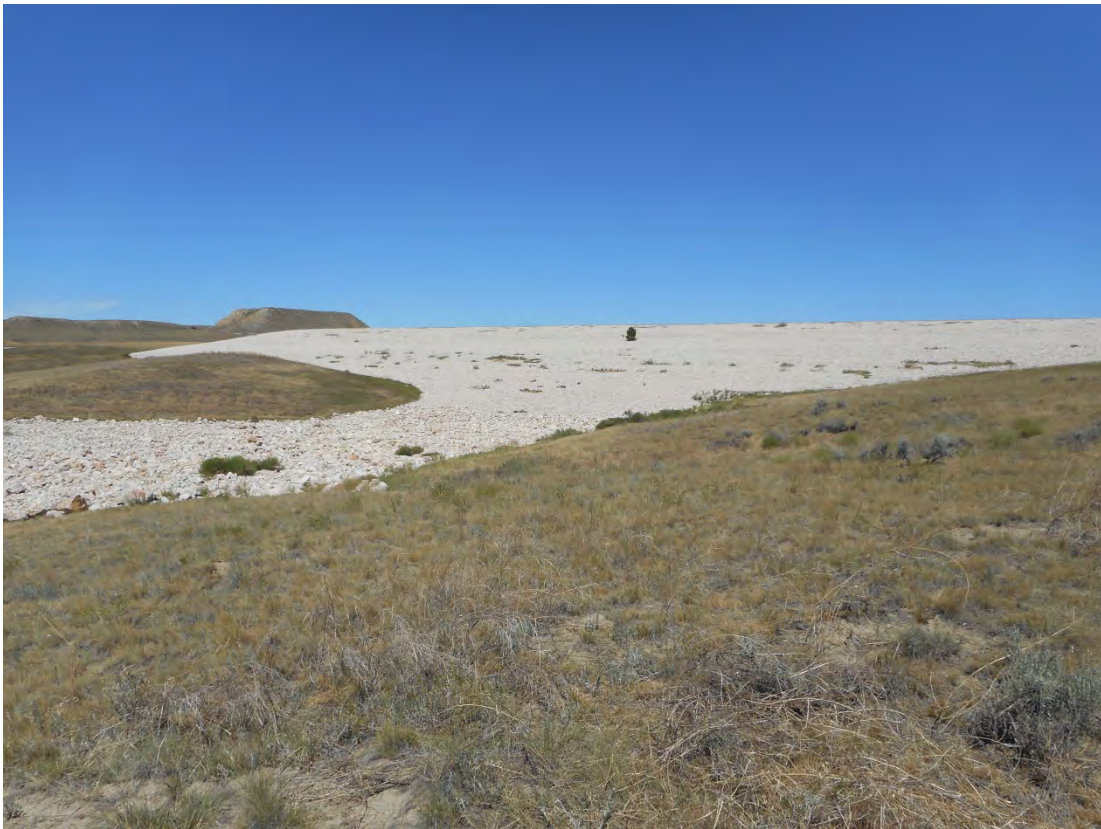
The tailings embankment face, the steepest man-made slope onsite, is covered with riprap and was intact and stable (PL-5). The riprap showed no signs of degradation. Scattered plants, mostly grass and annual weeds, grow in the riprap. These plants do not threaten the stability or function of the embankment face.

PL-5. Drainage Channel and Embankment, July 12, 2016

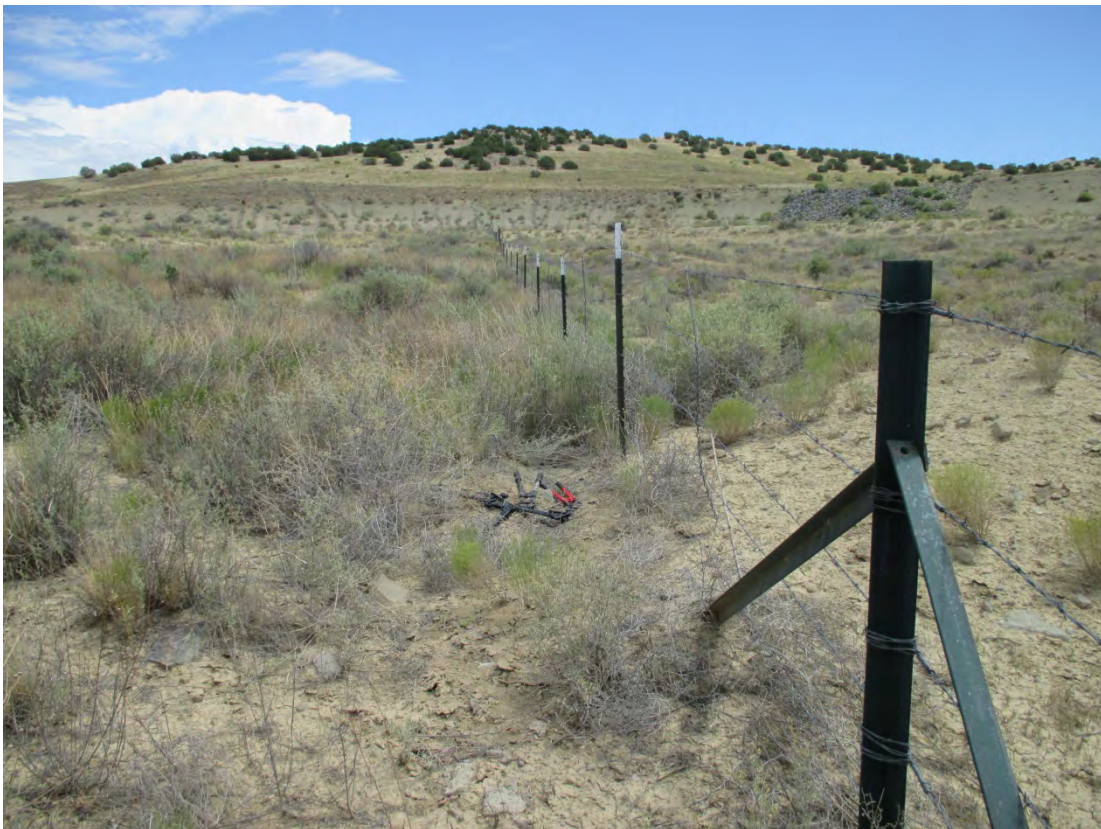
PL-2. Repaired Fence

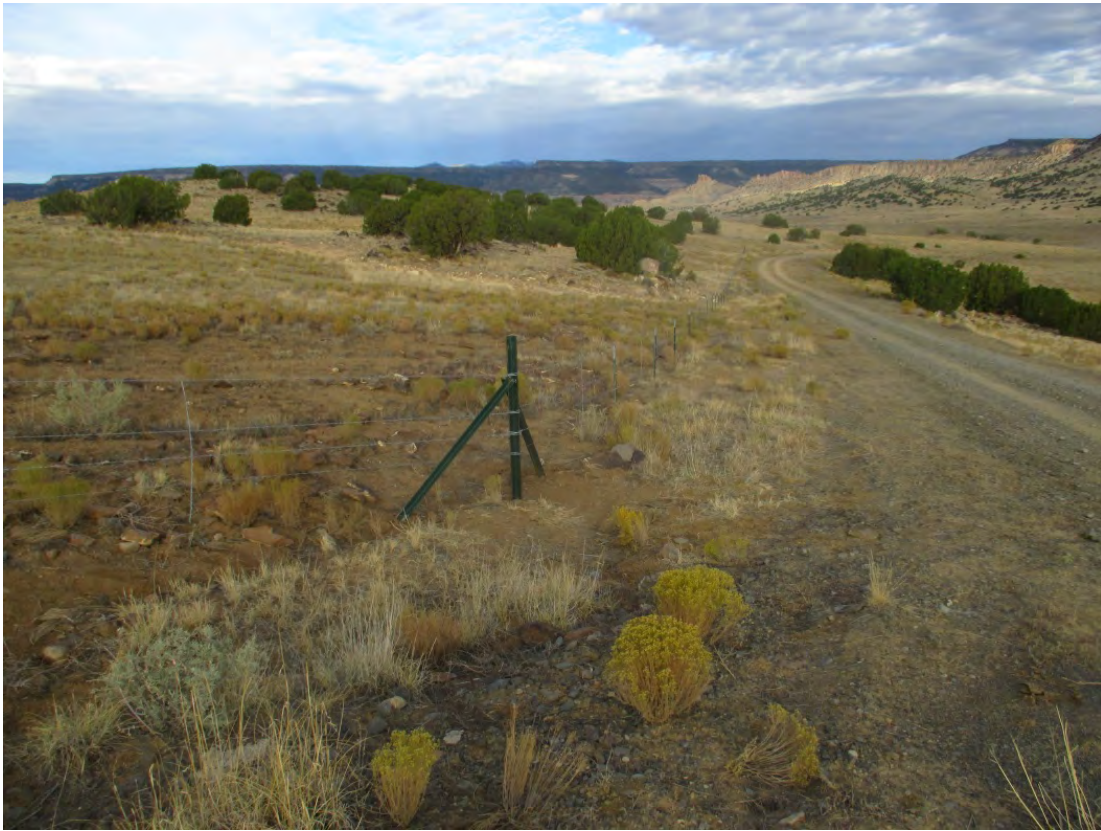
- **L-Bar, New Mexico:** Culvert installation was completed at a site access road to prevent further damage from an erosional gully. The section of fence along the east site access road was re-aligned to address impacts from erosion.
- **Sherwood, Washington:** An erosion feature is present at the toe of the tailings dam, and a forest fire on August 2016 impacted portions of the site. A follow-up inspection is planned for late 2016.
- **Shirley Basin South, Wyoming:** Concentrations of radium-226 and radium-228 continued to exceed their respective alternate concentration limits at three wells. NRC concluded that there is no current risk to human health and the environment. Groundwater monitoring will continue in accordance with the LTSP.

PL-3. New Fence Along East Site Access Road

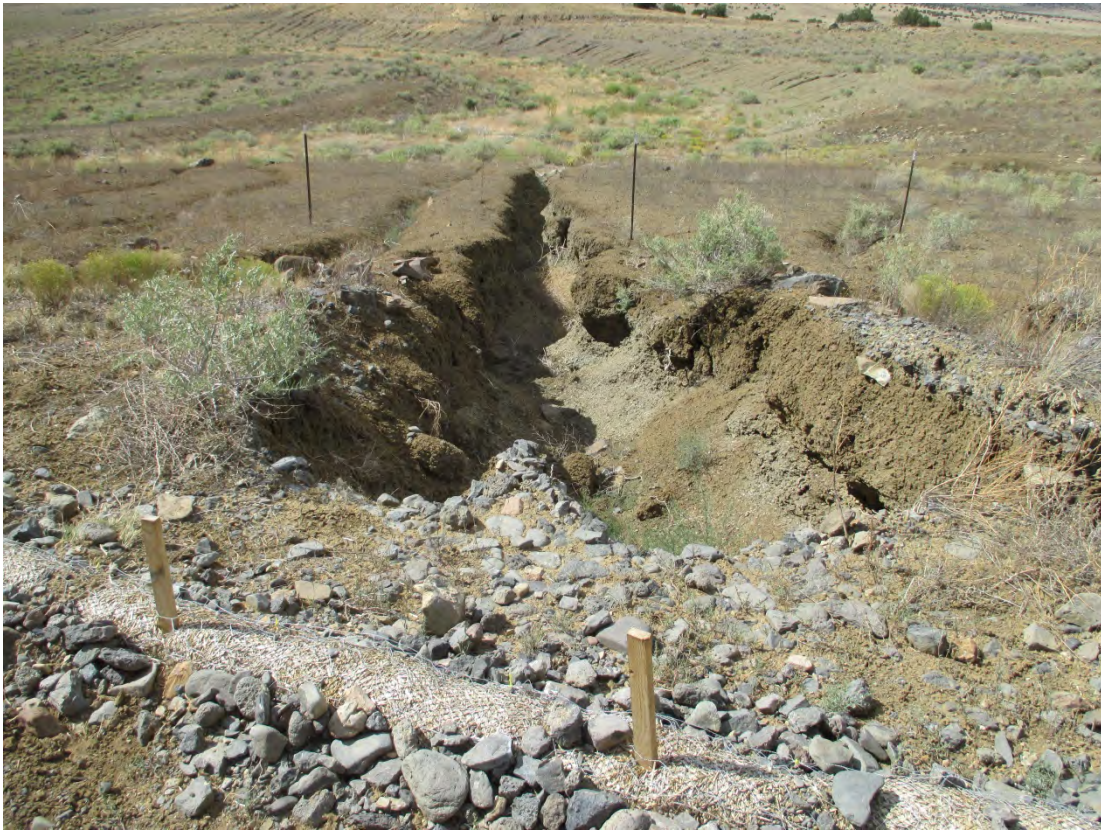
PL-11. Encroaching Gully Along East Access Road

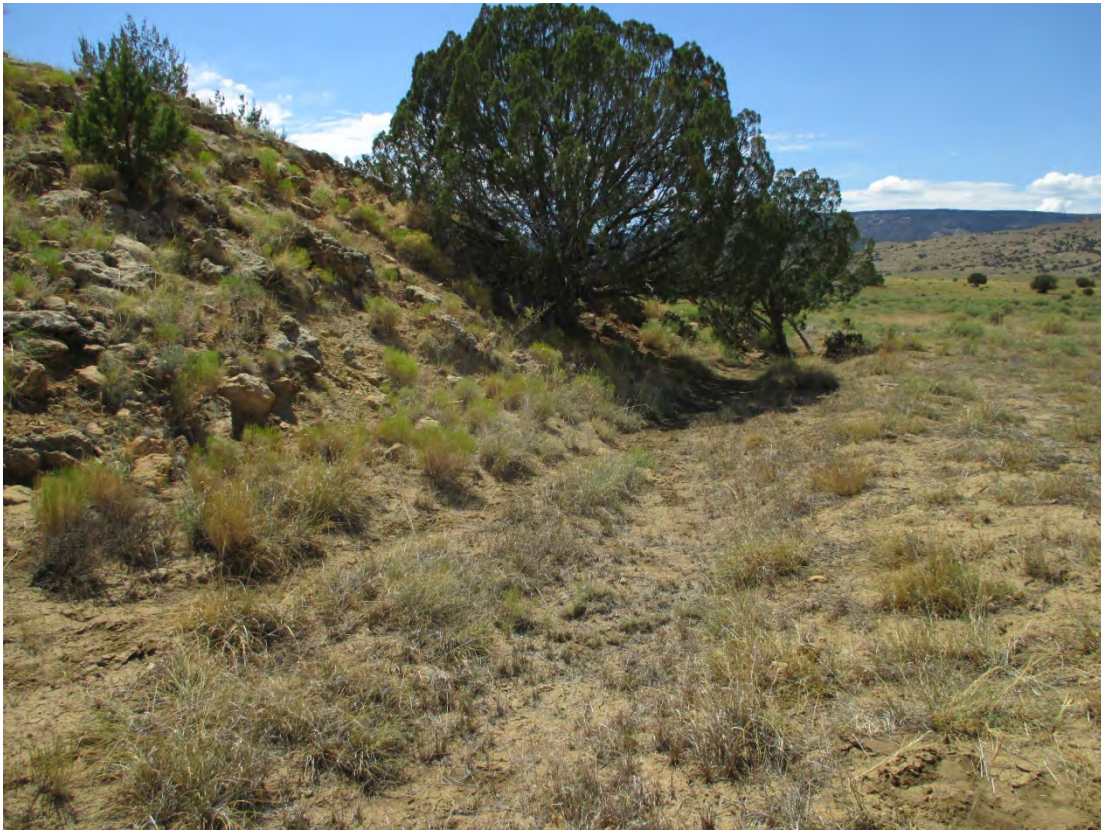
PL-15. Potential Seep Area at Tres Hermanos Sandstone Outcrop

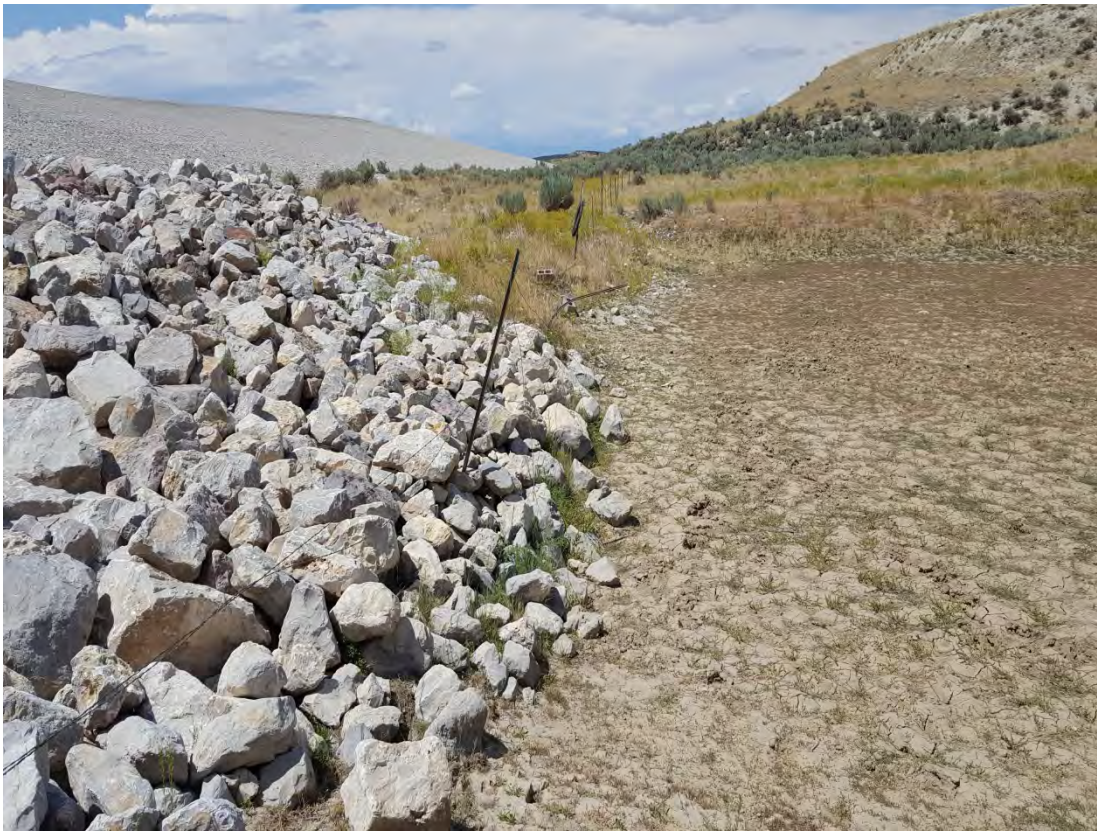
PL-1. Fence Damage East of Disposal Cell

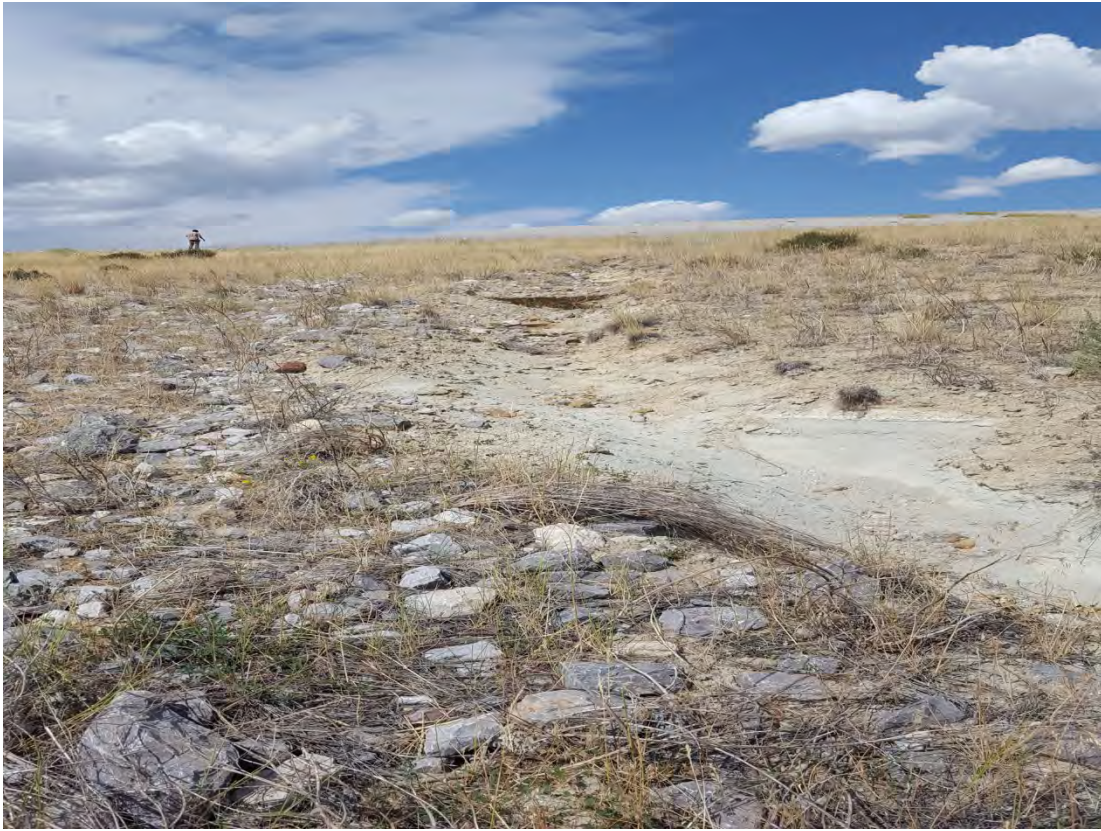
PL-13. Gully Southwest of Disposal Cell; Looking Upslope

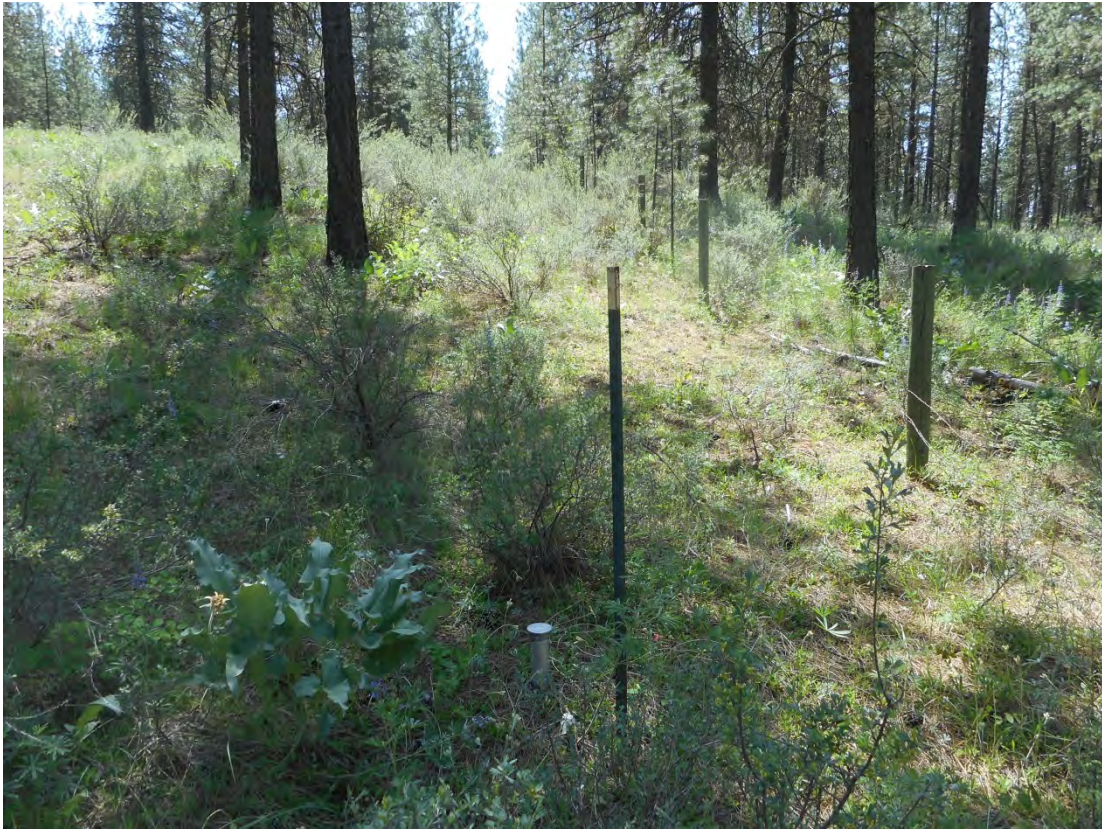
Six boundary monuments set in concrete define the site boundary (PL-3). Boundary monument BM-3A, near the granite site marker, is bent but does not need to be repaired. Because surrounding vegetation had made it difficult to locate some of the monuments, metal t-posts were installed at each monument location. All boundary monuments were verified to be present and stable during the 2016 inspection (PL-3).

PL-3. Boundary Monument BM-1

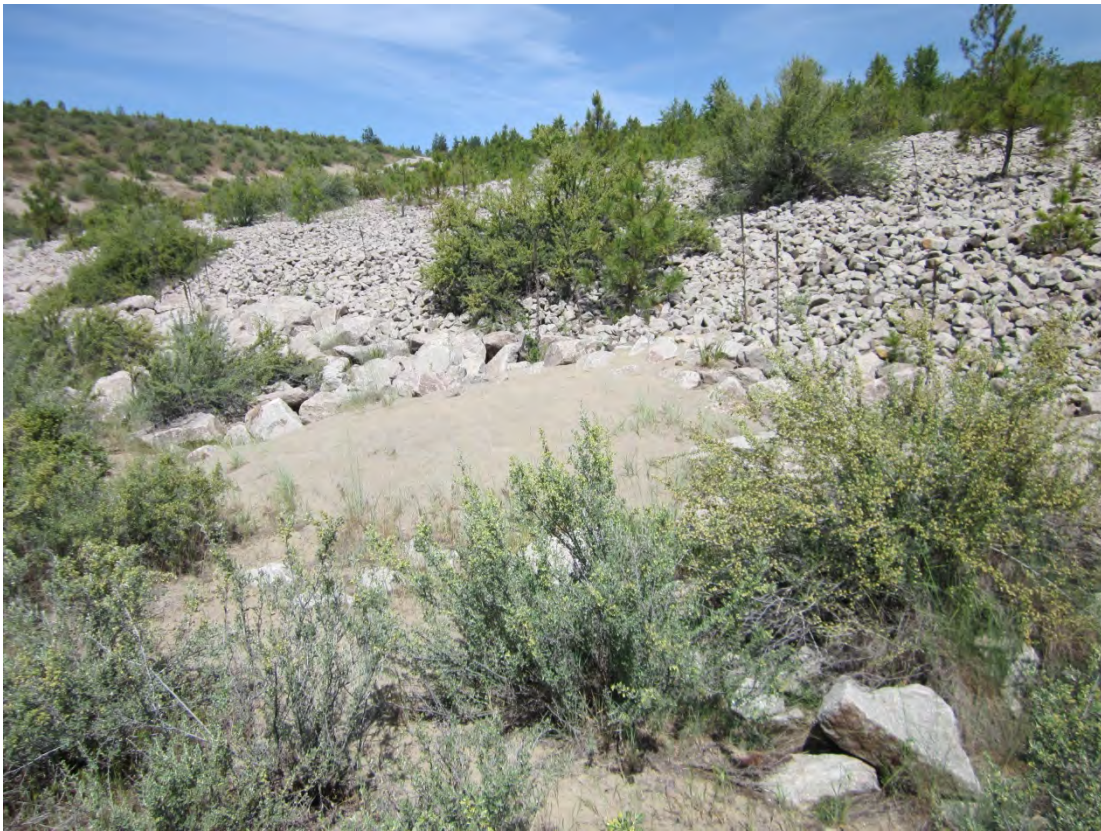
4-7	No groundwater monitoring is required by the LTSP.
Sherwood, Washington	5	5-5	Observed erosion feature at the toe of tailings dam.
		5-6	Conducted dam safety inspection.
		5-7	Follow-up inspection will occur in late 2016 due to an erosion feature and a forest fire.
		5-8	Conducted groundwater monitoring.
Shirley Basin South, Wyoming	6	6-7	Conducted groundwater monitoring.
		6-8	Continued to exceed ACLs for radium-226 and radium-228.
		6-9	Concluded that elevated radium concentrations pose no risk to human health and the environment.

PL-7. Erosion at Base of Dam, View to Northwest
